Tube Analysis Report

Manufacturer: York
Model Number: YTH3J3E2
Serial Number: 123456 #2

Inspected: February 20, 2008
Analyst: Rick Rives Level III

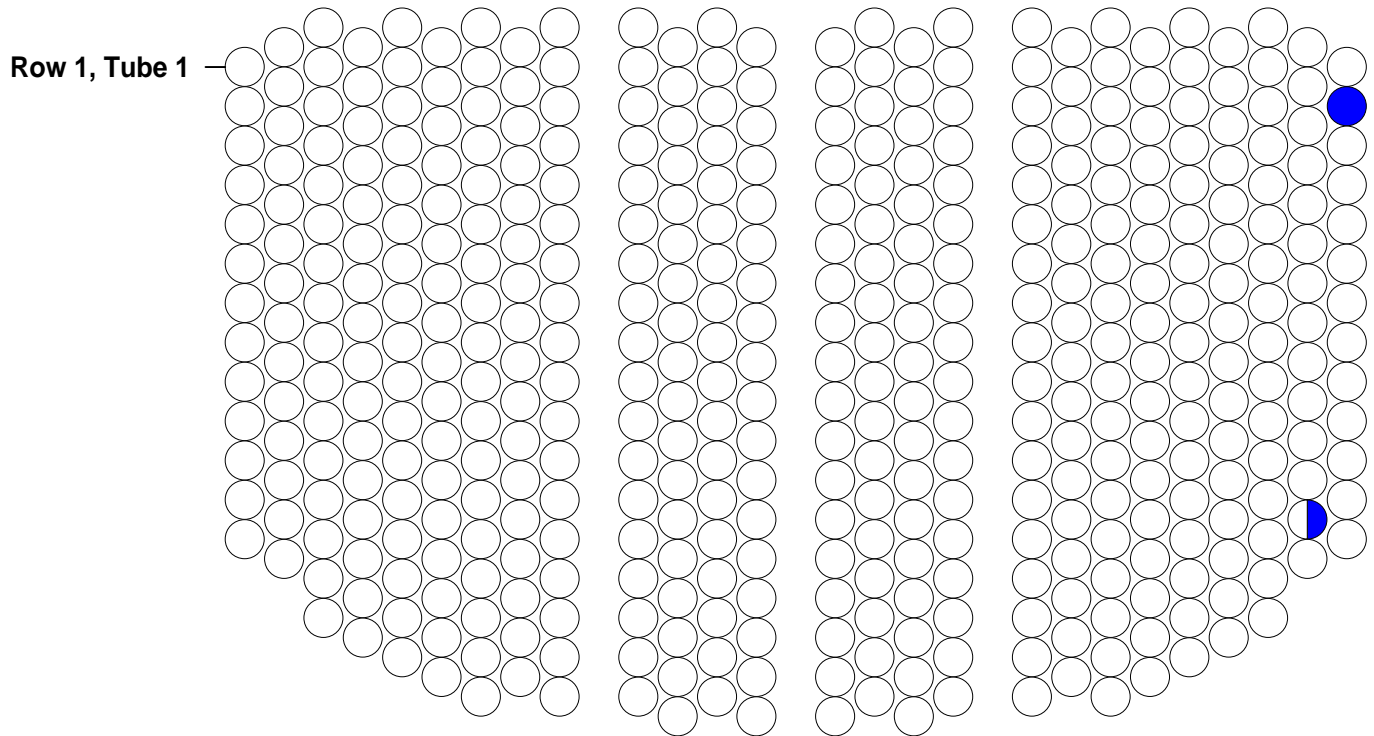
CONDENSER

The ID Defects noted are considered acceptable requiring no tube related repair.

NO REJECTED TUBES

- Accept, 434 tube(s), 99.54%, Accept
- ◐ ID Defect < 20%, 1 tube(s), 0.23%, Accept
- ID Defect < 40%, 1 tube(s), 0.23%, Accept

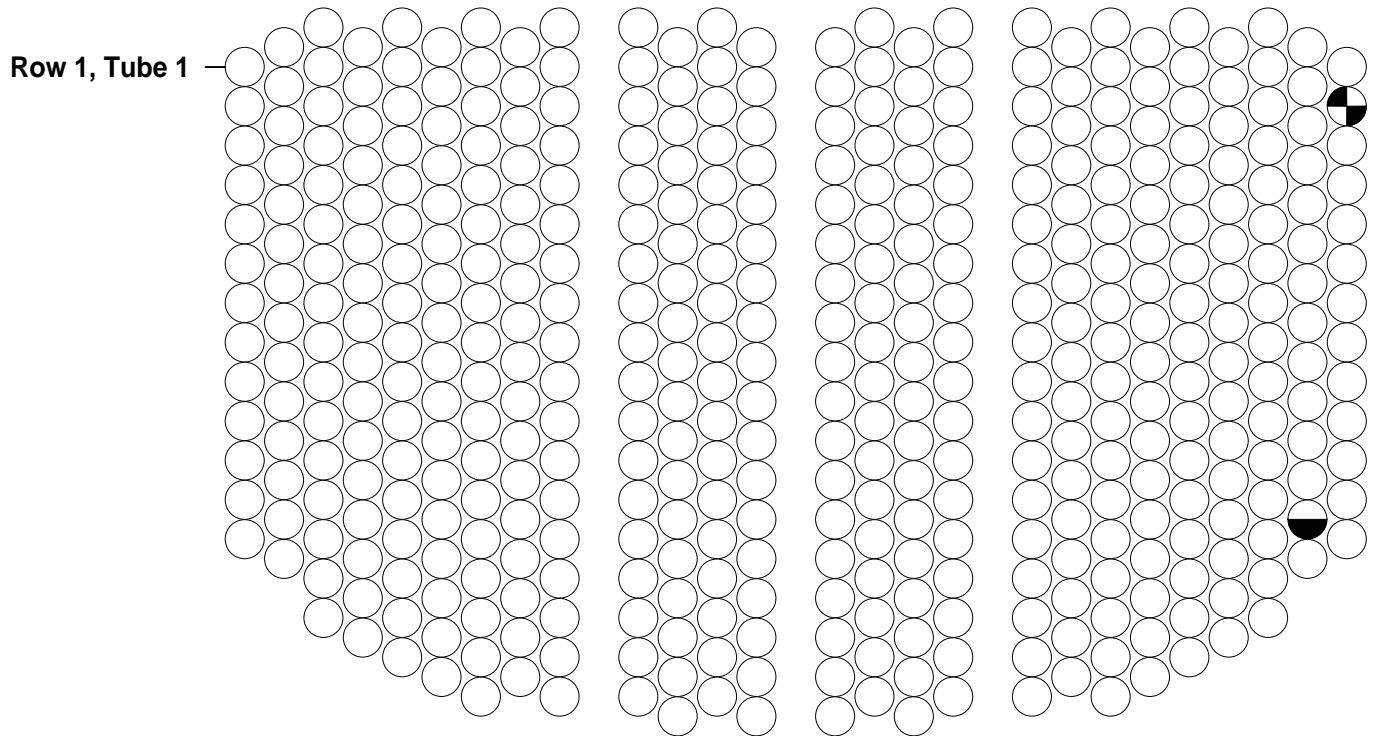
CONDENSER

NO REJECTED TUBES

- Accept, 434 tube(s), 99.54%, Accept
- ◐ ID Defect < 20%, 1 tube(s), 0.23%, Accept
- ◑ ID Defect < 40%, 1 tube(s), 0.23%, Accept

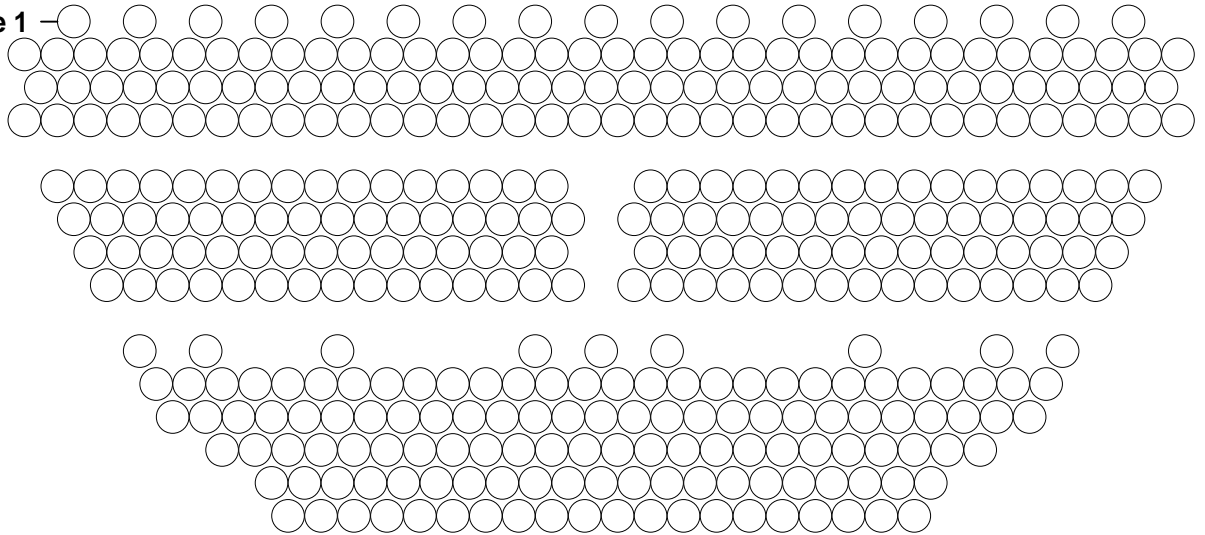
EVAPORATOR

No measurable defects were noted during this inspection.

NO REJECTED TUBES

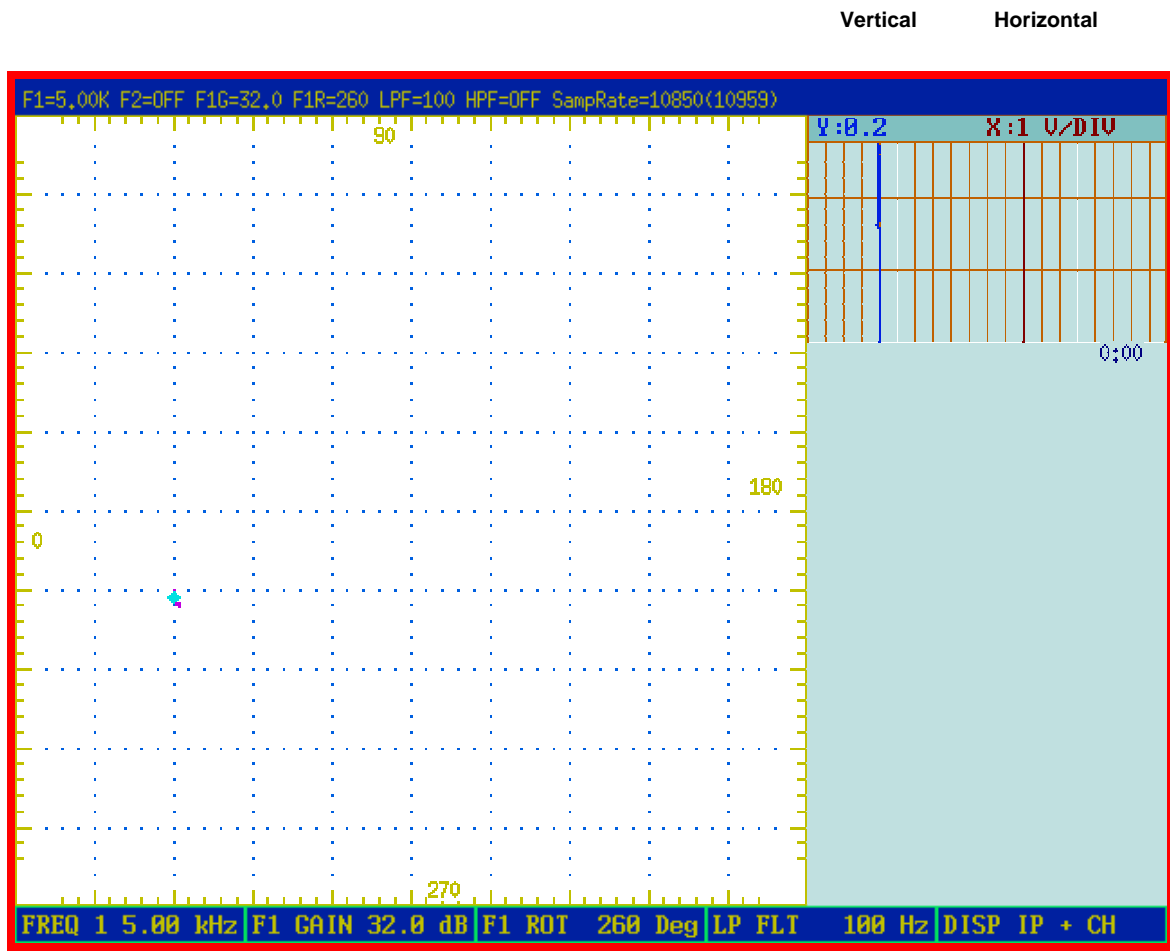
Row 25, Tube 13

ID Defect in Bay 4

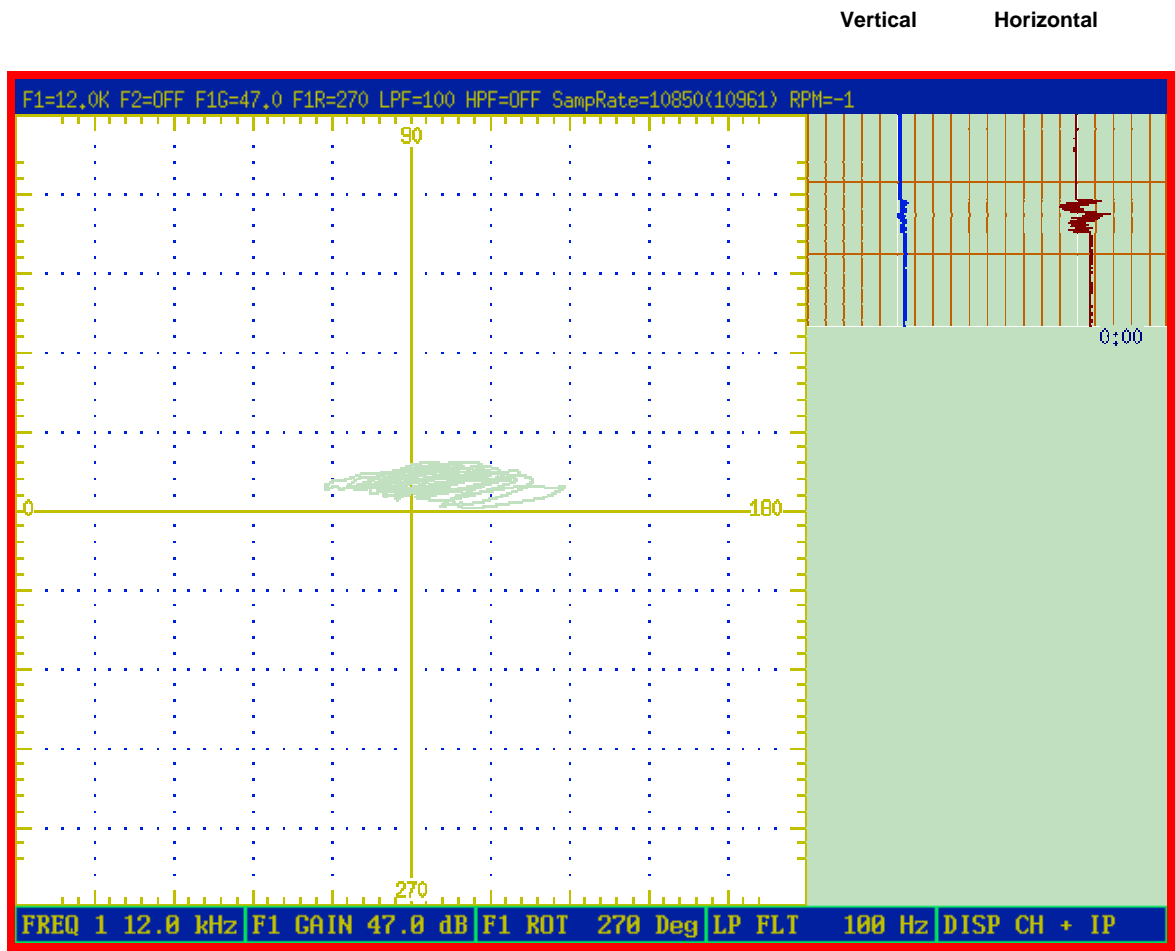
Row 25, Tube 13

ID Defect in Bay 4

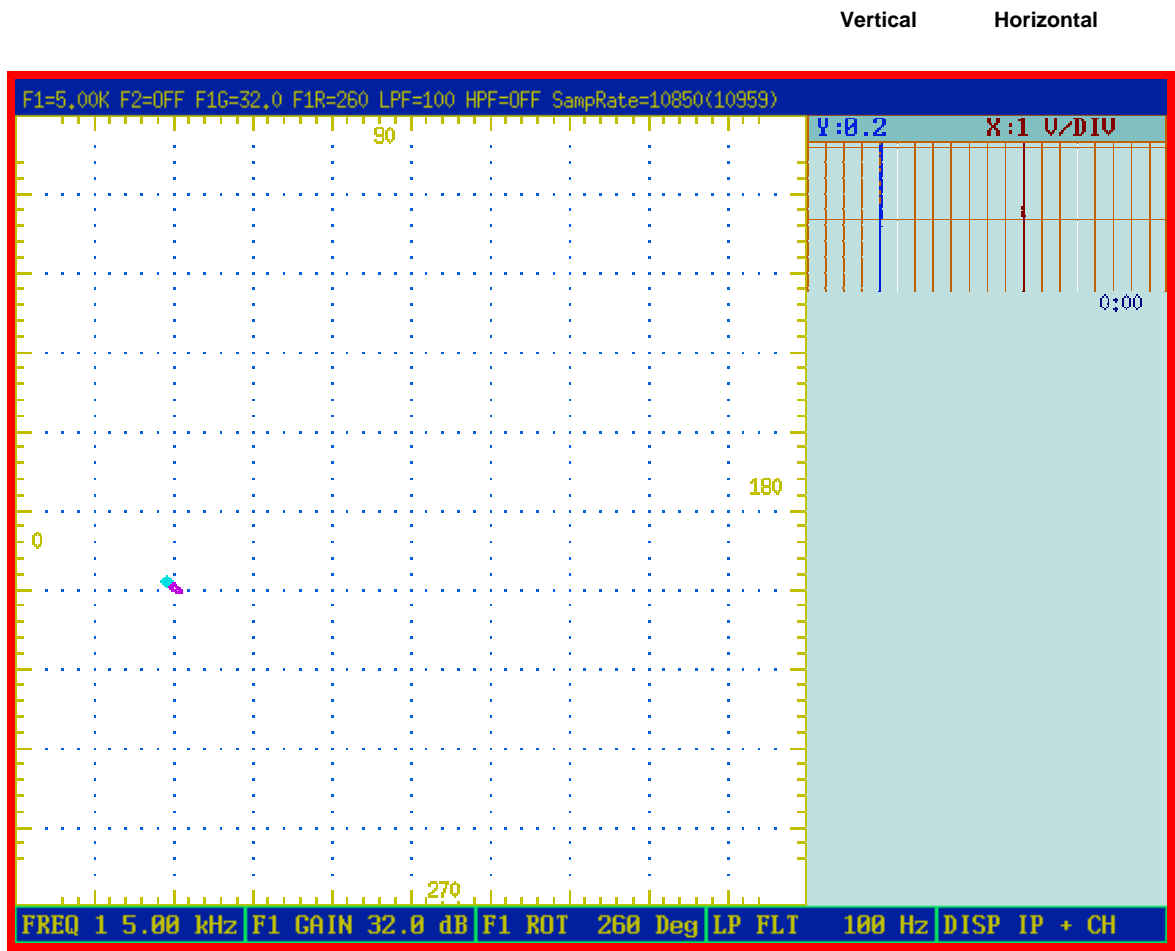
Row 26, Tube 2

ID Defect 9" from S3 in Bay 3

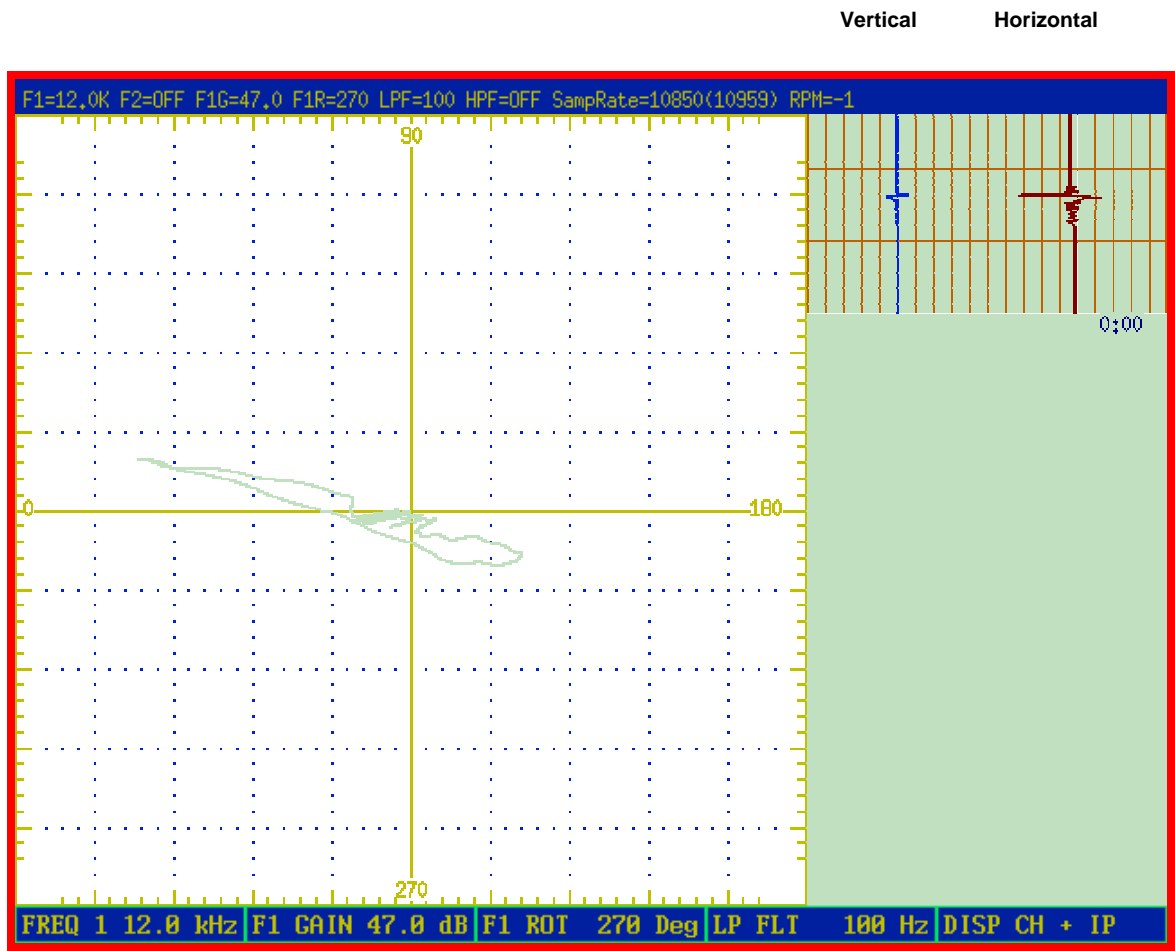
Row 26, Tube 2

ID Defect 9" from S3 in Bay 3

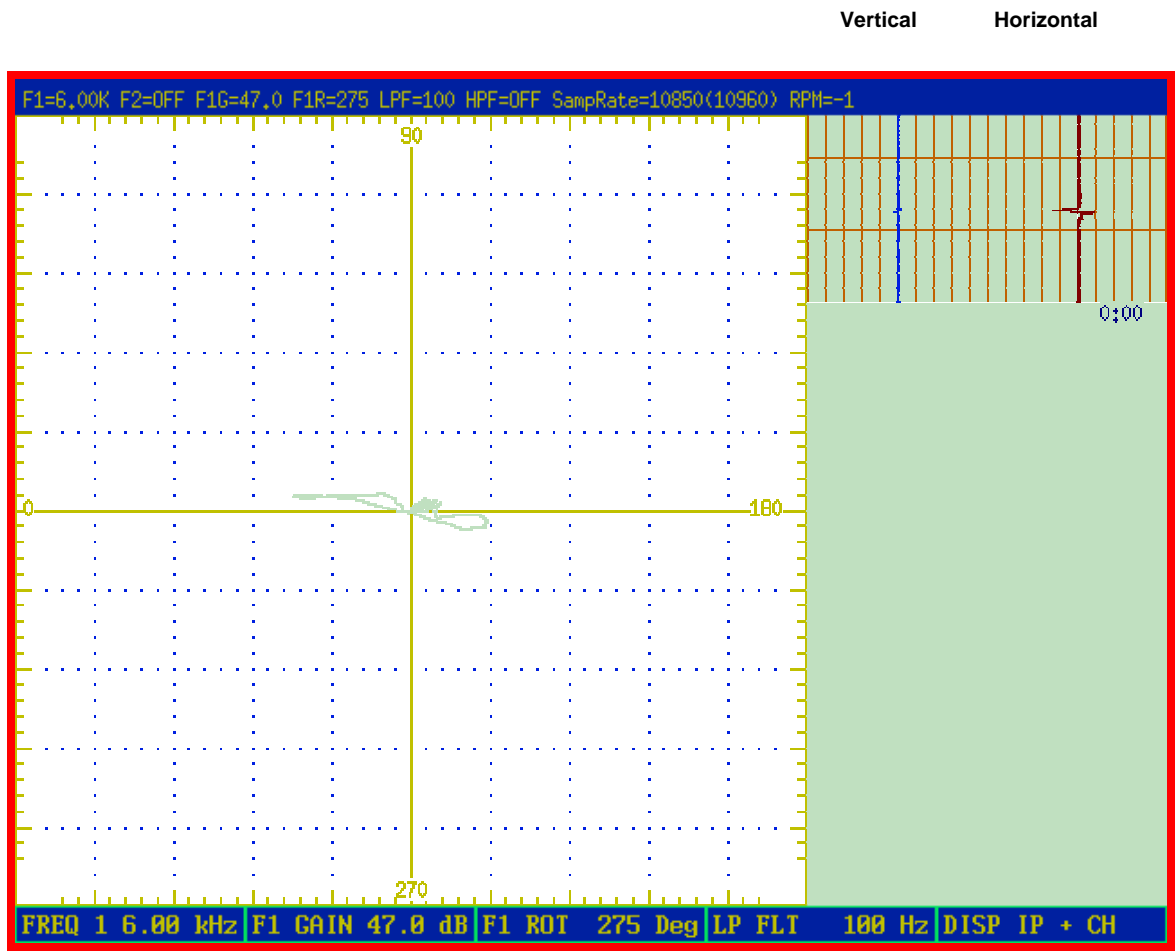
Row 26, Tube 2

ID Defect 9" from S3 in Bay 3

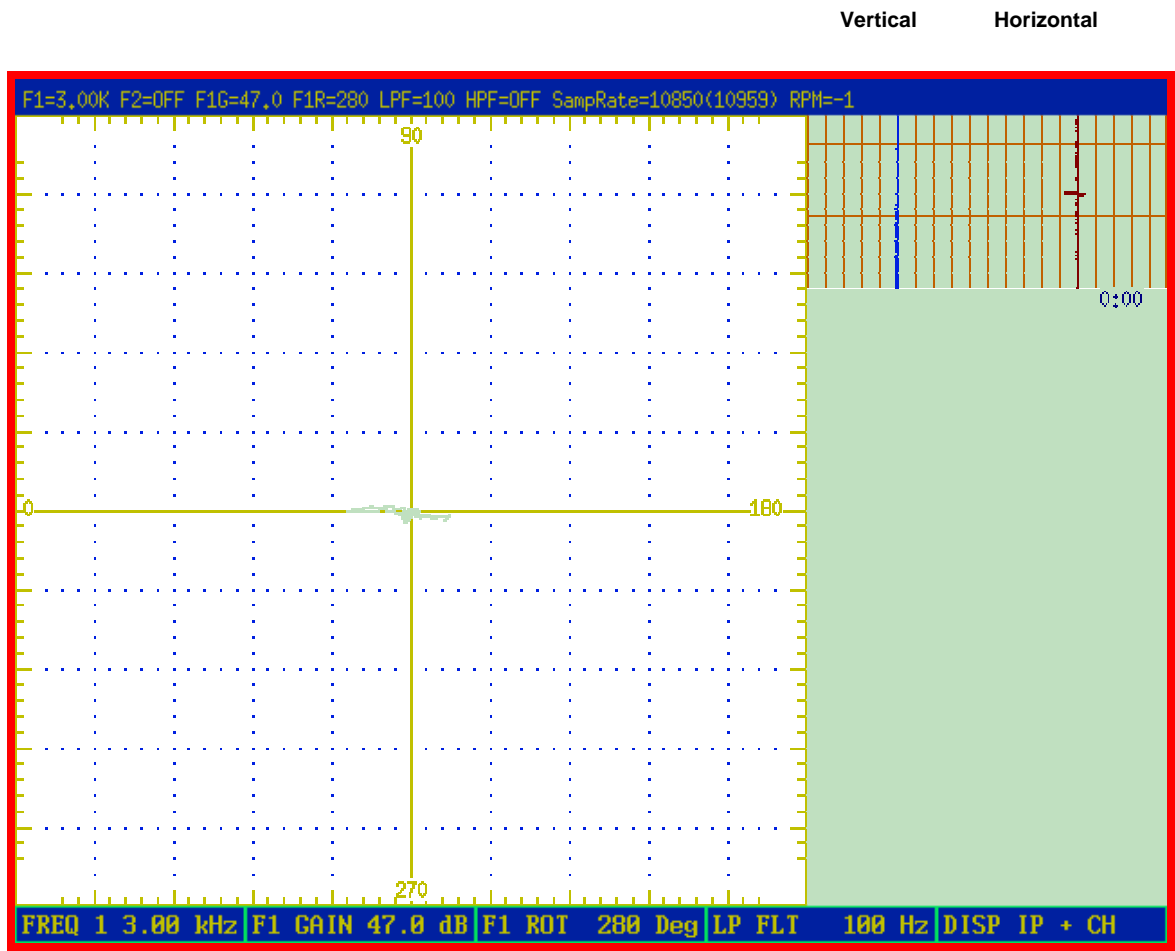
Row 26, Tube 2

ID Defect 9" from S3 in Bay 3
